## Evaluation of the San Jacinto Waste Pits Cap Defect

June 2016

Letter Report

Prepared for      U.S. EPA, Region 6  
Dallas, TX 75202

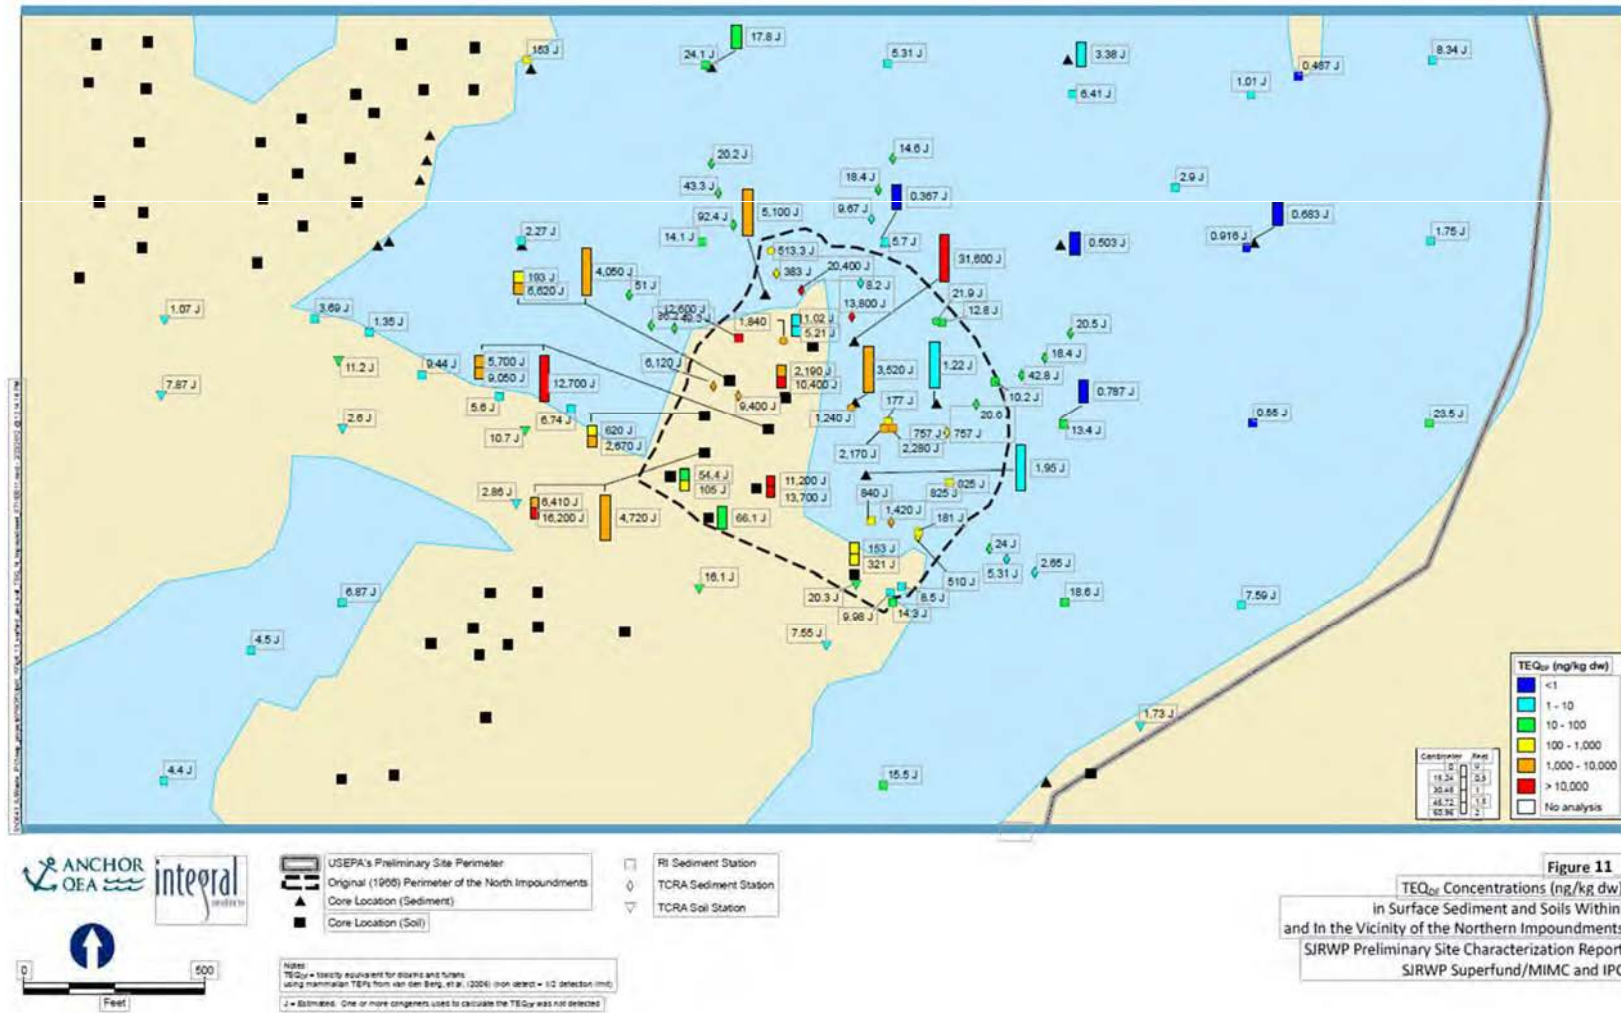
Figure 11. TEQDF Concentrations (ng/kg dw) in Surface Sediment and Soils Within and in the Vicinity of the Northern Impoundments.

Based on the reduction in magnitude from the sediment in the impacted zone versus the levels of the sediment collected by the northwestern toe, one can say that there were no significant releases from the exposed cap. If one compares the values by the toe and fifty feet from the toe to the data from the Feasibility Document shown in Figure 11, the sediment collected

The same analysis that was done for Task 5 applies here too. Since it was demonstrated that there was no significant increase in contamination at the two sites away from the exposed sediment in armor cap area as compared to historical data (Feasibility Report, Figure 11) then the release from the other contaminants should behave similarly. If one looks at the fingerprint of the contamination for the samples collected from the exposed sediment, one sees that ratio of TCDD to TCDF is not similar to the fingerprint of the two sites ((1)SJNE085 and SJNE 086, (2) SJNE87 and SJNE88) outside the armor cap where the fraction of OCDD is dominant. As presented in the Feasibility Report the fingerprint from the SJRWP exhibits a different pattern than the pattern from other sources of dioxins and furans in the vicinity of San Jacinto. Figure 12 shows the two models for dioxin and furan that describe the pit (EM2) and the outside of the pit (EM1).

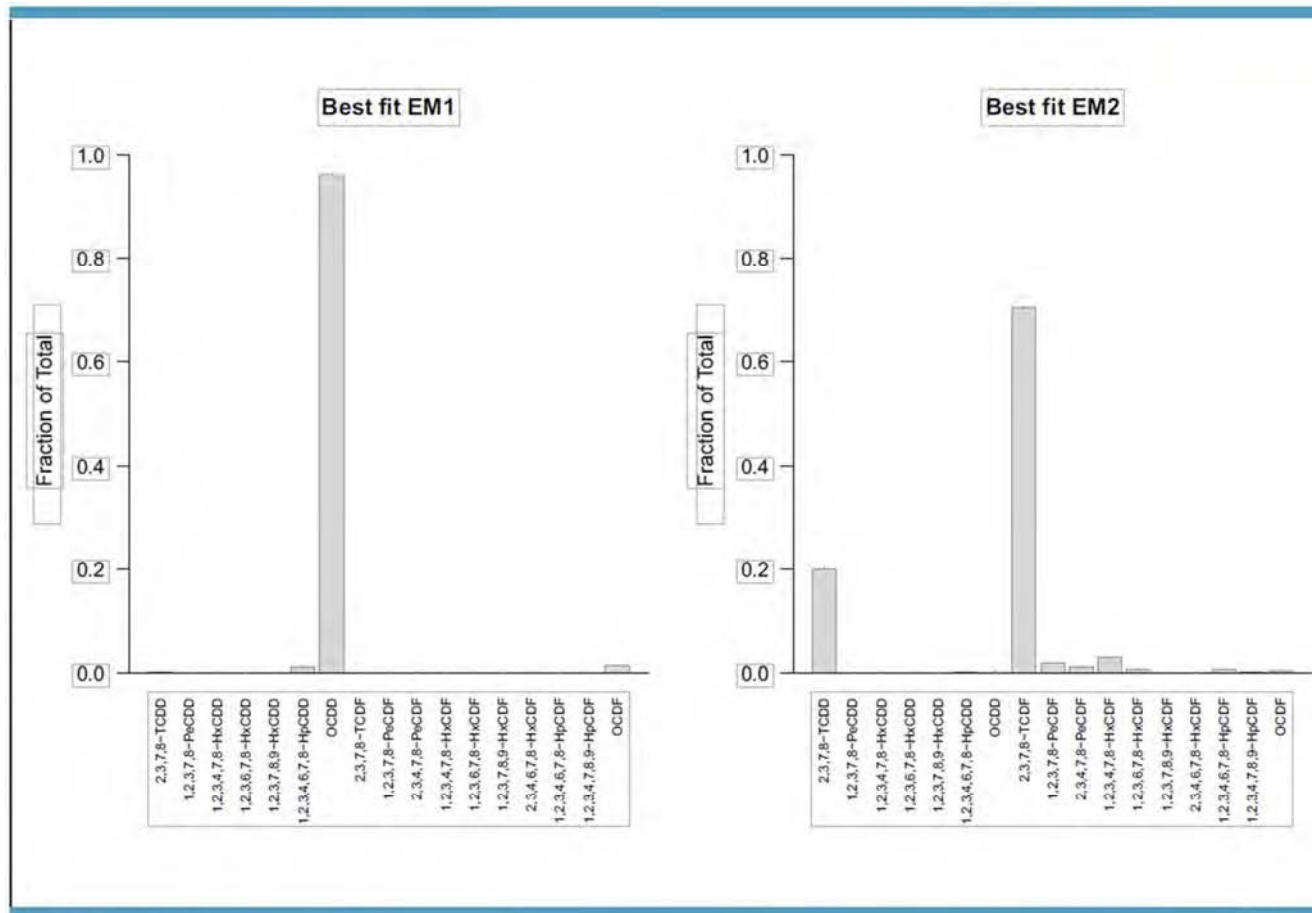
Figure 12. Patterns of Dioxin and Furan Congeners in the End Members of the Best Fit Unmixing Model.

Comparison of Figure 12 with Figures 9 and 10 shows that the fingerprint from the sediments collected in the deficient area is close to the EM2 model, while the data from the sites outside the exposed area follow the EM1 model. If sediment from the deficient area was released the impacted sites would exhibit a form of the EM2 model (fingerprint), one can say that there is a slight contribution by the short peak of TCDF, so most of the sediment from the toe and outside areas receive most of the loadings from other areas beside the SJRWP. In addition, the samples from the deficient area show evidence of deposition of sediment from outside the SJRWP due to presence of higher distribution of OCDD than in the EM2 model. The presence of deposition in the deficient area would indicate the long-term presence of the defect, the stability of sediment at the defect, and no significant release of contaminants from the deficient area.

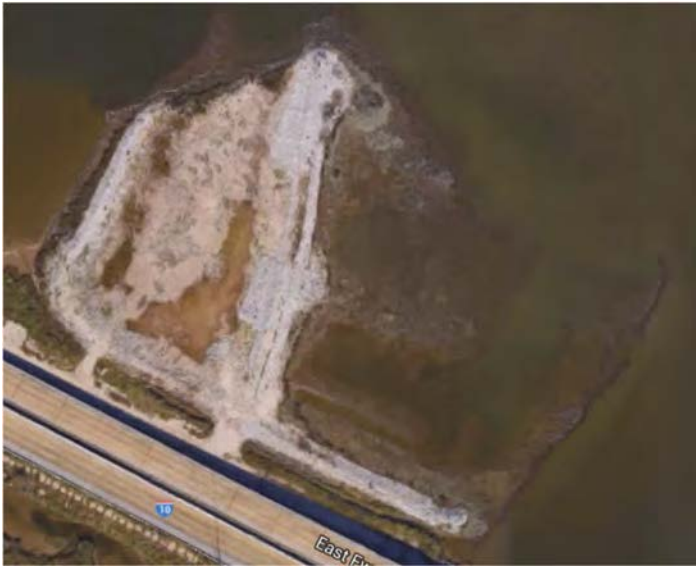
**Figure A3. Deficiency area marked with pvc pipe.**
